**UNITED STATES DEPARTMENT OF THE INTERIOR  
BUREAU OF SAFETY AND ENVIRONMENTAL ENFORCEMENT  
SUBMITTAL REPORT**

Operator: BP Exploration & Production Inc. (02481)  
 Business Process: Pipeline Permits and Reports  
 Submittal Type: Plan of Corrective Action  
 Project Name: Nakika  
 Submittal Coordinator:  
 Submittal Status: Submitted  
 Submittal ID: 196848967  
 Status Date: 01-FEB-2021  
 Submittal Description: Na Kika Galapagos Loop Revised Corrective Action  
 Remarks: bp was able to move forward to execute the revised corrective action plan approved on December 17, 2020 as described in Section 3 of the attached revised plan. The revised CAP was executed on January 7 & 10, 2020 and the current status is detailed in Section 3.1.  
 bp requests to move forward to execute the additional corrective action for temporary loop reconfiguration as described in Section 4 of the revised plan and hereby submits the enclosed revised Corrective Action Plan to your office for review and approval.

# Galapagos LSPS Corrective Action Plan - Temporary Reconfiguration

Reference: 2020 Plan of Corrective Action - Revised  
Segment No. 16283

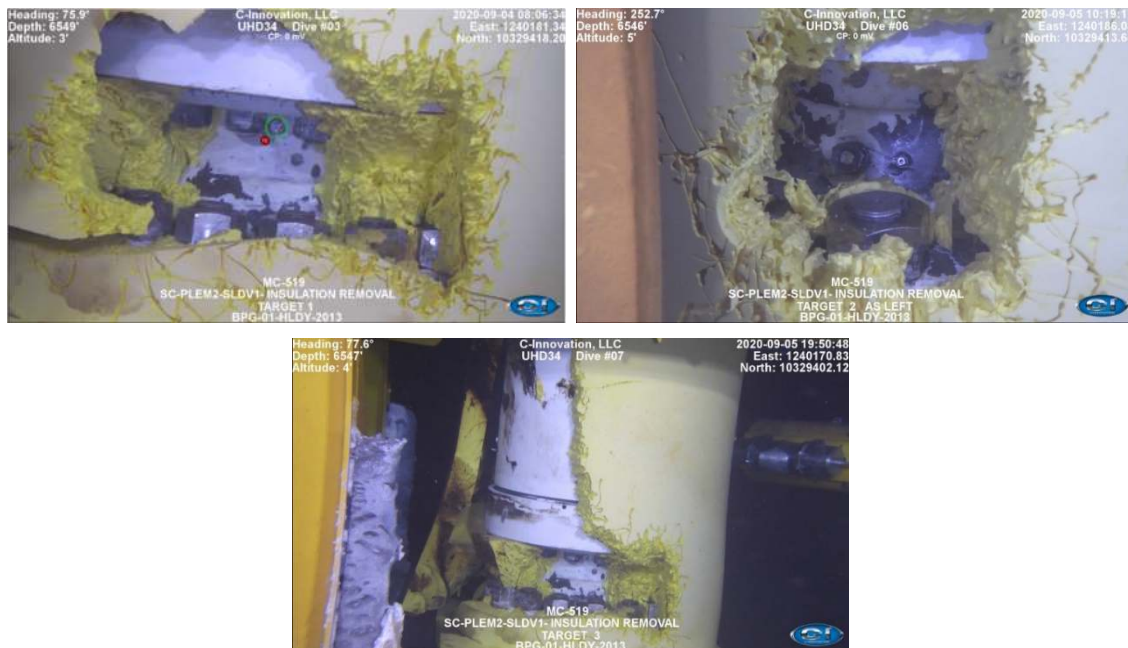
Figure 2: Insulation Removal Results for Grease Port and Disbonded Insulation (Targets 1-3)

**3 - 5 September 2020** – Insulation was removed (Figure 2) at grease port locations and other areas where it had disbonded on the SLDV1 valve located at the SC PLEM2. While the insulation removal campaign was unable to identify the leak source, results indicated that additional insulation removal would increase the probability of determining the leak source.

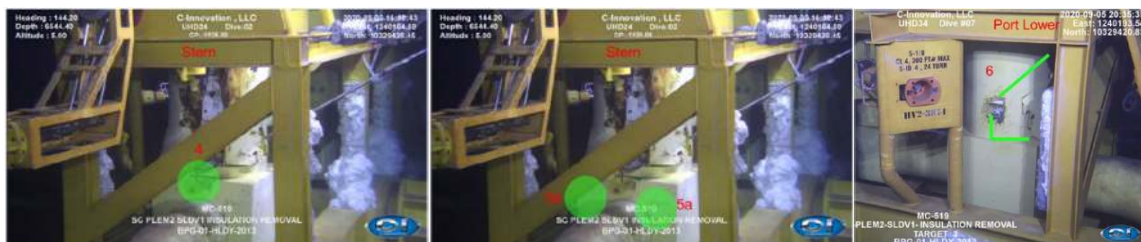
Figure 3: Additional Insulation Removal Targets (Targets 4-6)

**25 - 29 September 2020** – Following approval of previous Corrective Action Plan on 14 September 2020, additional insulation was removed (Figures 3 – 5) as attempts to pressurize the SC PLEM2 failed due to lack of communication to the bore.

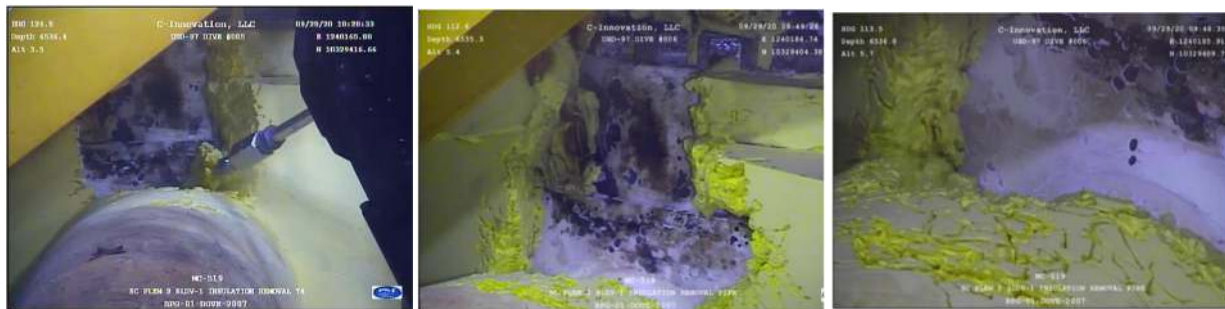
Figure 4: Insulation Removal Results for Targets 4, 5a and 5b

While additional insulation removal was unable to identify the leak source, visibility at the areas of interest (targets) had been improved and the likelihood of finding the leak source during pressurization has increased.

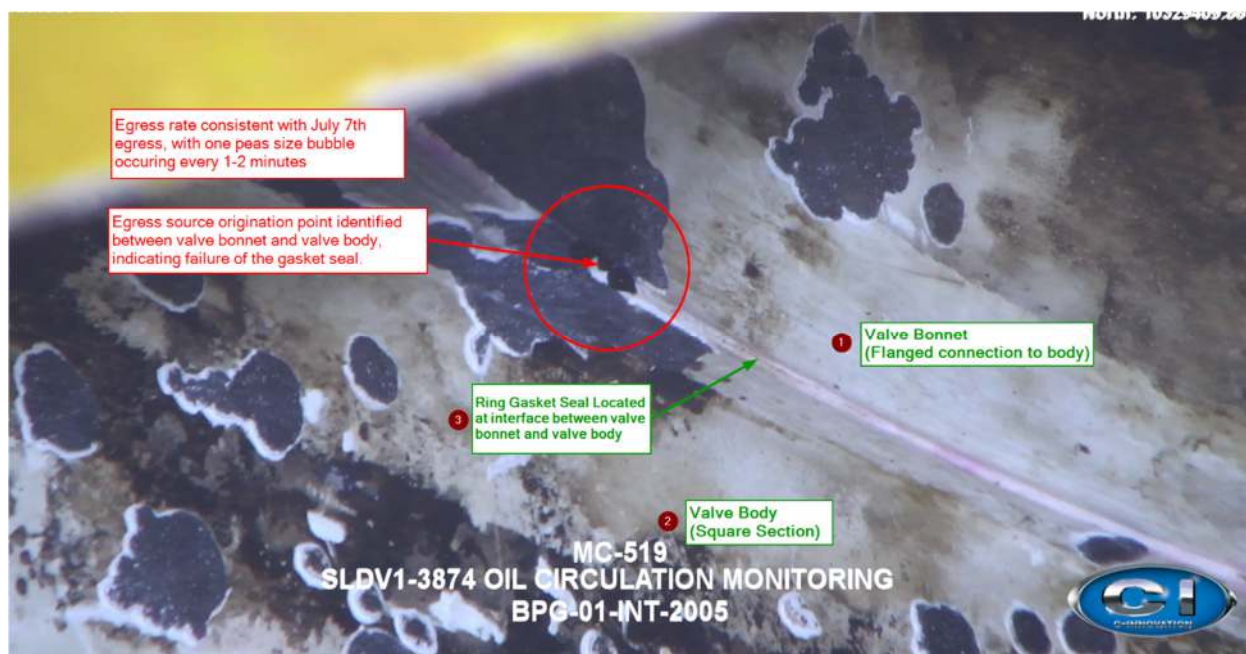
Figure 6: Egress Location

**10 – 16 November 2020:** During dead oil circulation, the ROV observed dead oil or other fluid egress from the SLDV1 valve located at SC PLEM 2. The egress source origination point was identified as the gasket seal located between the valve bonnet and valve body; see Figure 6. ROV was utilized to collect the egressed volume located under the containment dome and the collected sample bottle returns [were sent to Core Labs for testing, which found no hydrocarbons in the samples](#). No additional egress points were identified during the circulation test.

Egress was witnessed at 14:40 on 15 November following roughly 36 hours of circulation. The egress rate was estimated to be a single pea size bubble ( $1 \text{ cm}^3$ ) releasing at an interval of 1 to 2 minutes. The last witnessed release was at 04:23 on 16 November, with the pressure in the SC2 PLEM returning to below hydrostatic conditions at roughly 5:15. The volume of the release is therefore estimated to be between  $411 \text{ cm}^3$  (.10 gal) and  $875 \text{ cm}^3$  (.23 gallons). No additional bubbles were observed after the pressure was returned to below hydrostatic conditions.

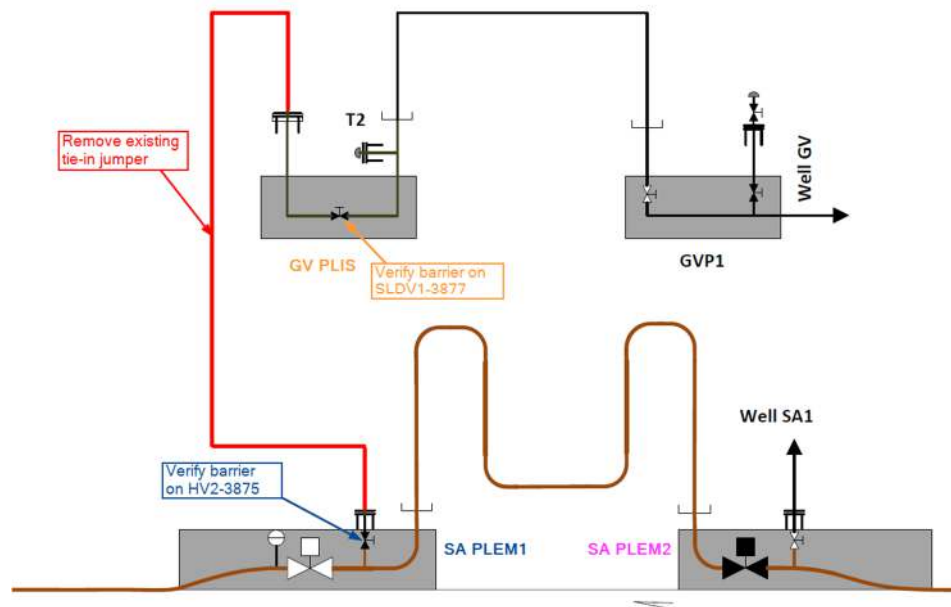
Figure 9: Removal of Existing Tie-in Jumper

**Equipment Status:** PLIS Jumper is currently filled with water based fluids (MEG/water) and has not flowed hydrocarbons since installation.

**Task:** Removal & Recovery of the existing tie-in jumper between GV PLIS and SA PLEM1.

1. Verify barrier isolation to SLDV1-3877 located at GV PLIS and HV2-3875 located at SA PLEM1
2. ROV to cut jumper assembly into sections and place in subsea basket for recovery to the surface. Crane support may be required during cutting operations.
3. Jumper end connections to be removed via OEM Tooling and recovered to the surface.

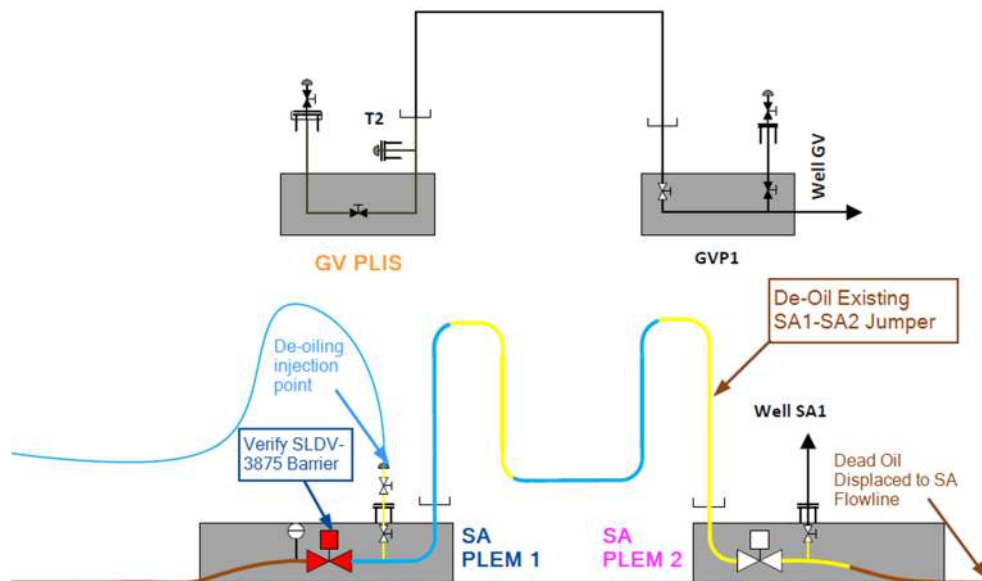
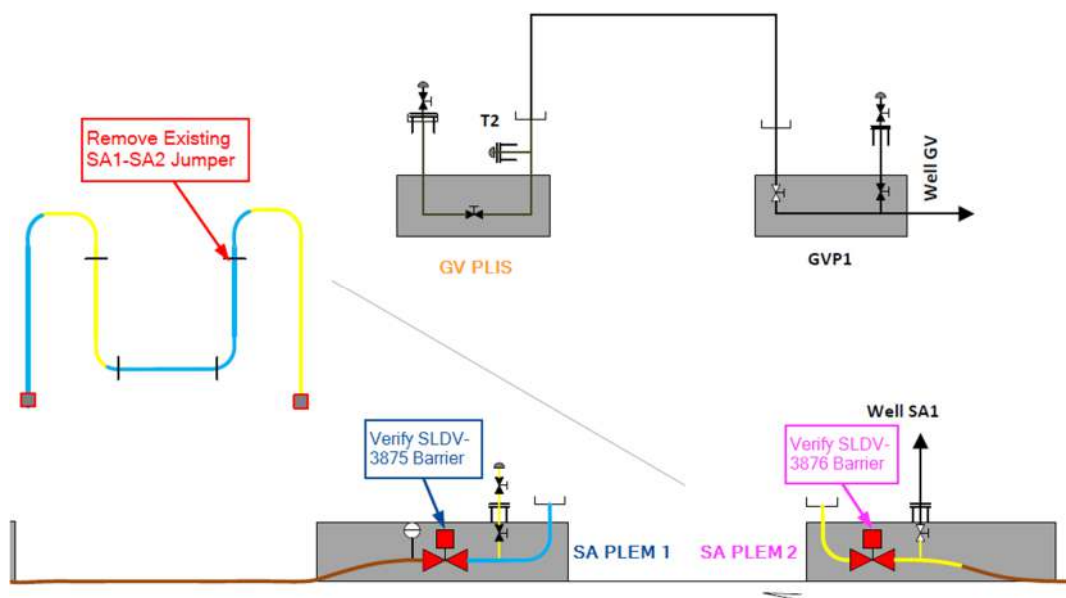
**Equipment Status:** Jumper is currently filled with dead oil from previous hot oil circulation.

**Task:** De-oiling, Removal and Recovery of the existing flowline jumper between the SA PLEM1 and SA PLEM2.

1. Verify barrier isolation at on SLDV1-3875 located at SA PLEM2.
2. Verify SLDV2-3876 located at SA PLEM2 is open to allow jumper fluid displacement to platform.
3. ROV to displace the existing dead oil in jumper by injection of two fluids via subsea pumping. To increase the efficacy of the de-oiling, fluids have been selected that have densities that are both above and below the existing production fluid, essentially bracketing the existing oil. Displacement fluids currently selected are Methanol and Mono-Ethylene glycol.

4. ROV to cut jumper assembly into sections and place in subsea basket for recovery to the surface. Crane support may be required during cutting operations.
5. Jumper end connections to be removed via OEM Tooling and recovered to the surface.

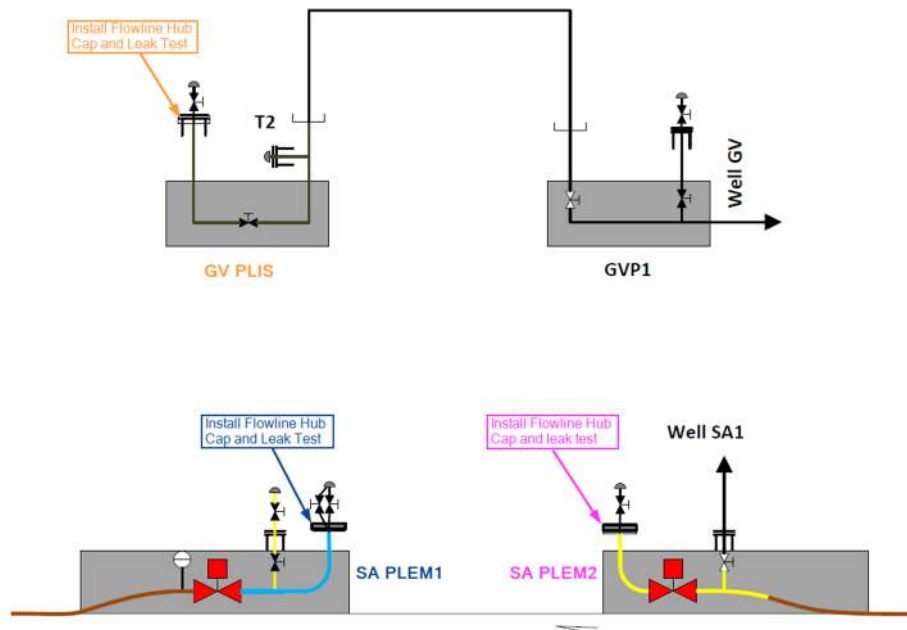
Figure 12: Cap Installation and Leak Test

**Equipment Status:** Refurbished flowline caps procured from OEM for field utilization. Caps are rated to MAOP of flowline and include necessary interfaces for ROV intervention. Existing flowline hubs have no known integrity issues.

**Task:** Installation of flowline hub caps on the newly exposed flowline jumper hubs (GV PLIS, SA BH1, SA FLH1 SA FLH2) and subsequent leak test.

1. Deploy Caps with vessel crane and install on exposed flowline jumper hub(s) with ROV support.
2. Utilize ROV to Perform leak test to verify connection and barrier integrity.

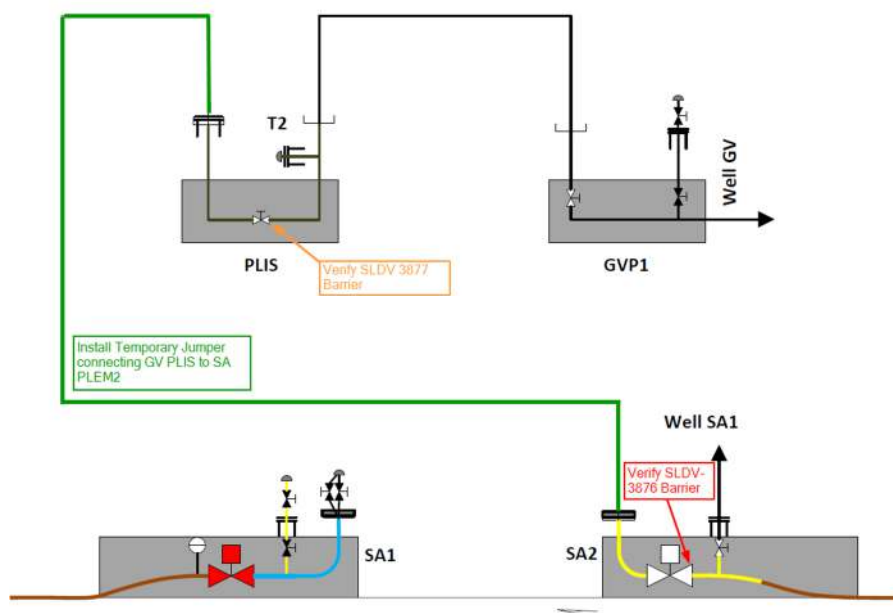
Figure 14: Temporary Jumper Install

**Equipment Status:** The temporary Jumper is being fabricated (by Fieldwood Energy) and is currently on schedule to meet current offshore readiness dates. Final fabrication will commence after receiving metrology after in-place jumpers are removed. Jumper assembly to be rated to MAOP of flowline and include necessary interfaces for ROV intervention.

**Task:** Installation of Temporary Jumper between GV PLIS and SA2 PLEM and subsequent leak test(s).

1. Verify barrier isolation at on SLDV1-3877 located at GV PLIS and SLDV1-3876 located at SA PLEM2
2. Utilize vessel crane to deploy and install jumper assembly ends utilizing ROV support and required OEM tooling
3. Utilize ROV to perform jumper seal tests to verify connection and barrier integrity.
